# BUREAU OF SHIPS GROUP TECHNICAL INSPECTION REPORT

⑥ OPERATION CROSSROADS.  
U.S.S. DAWSON (APA79)

TEST ABLE (U).

OPERATION CROSSROADS

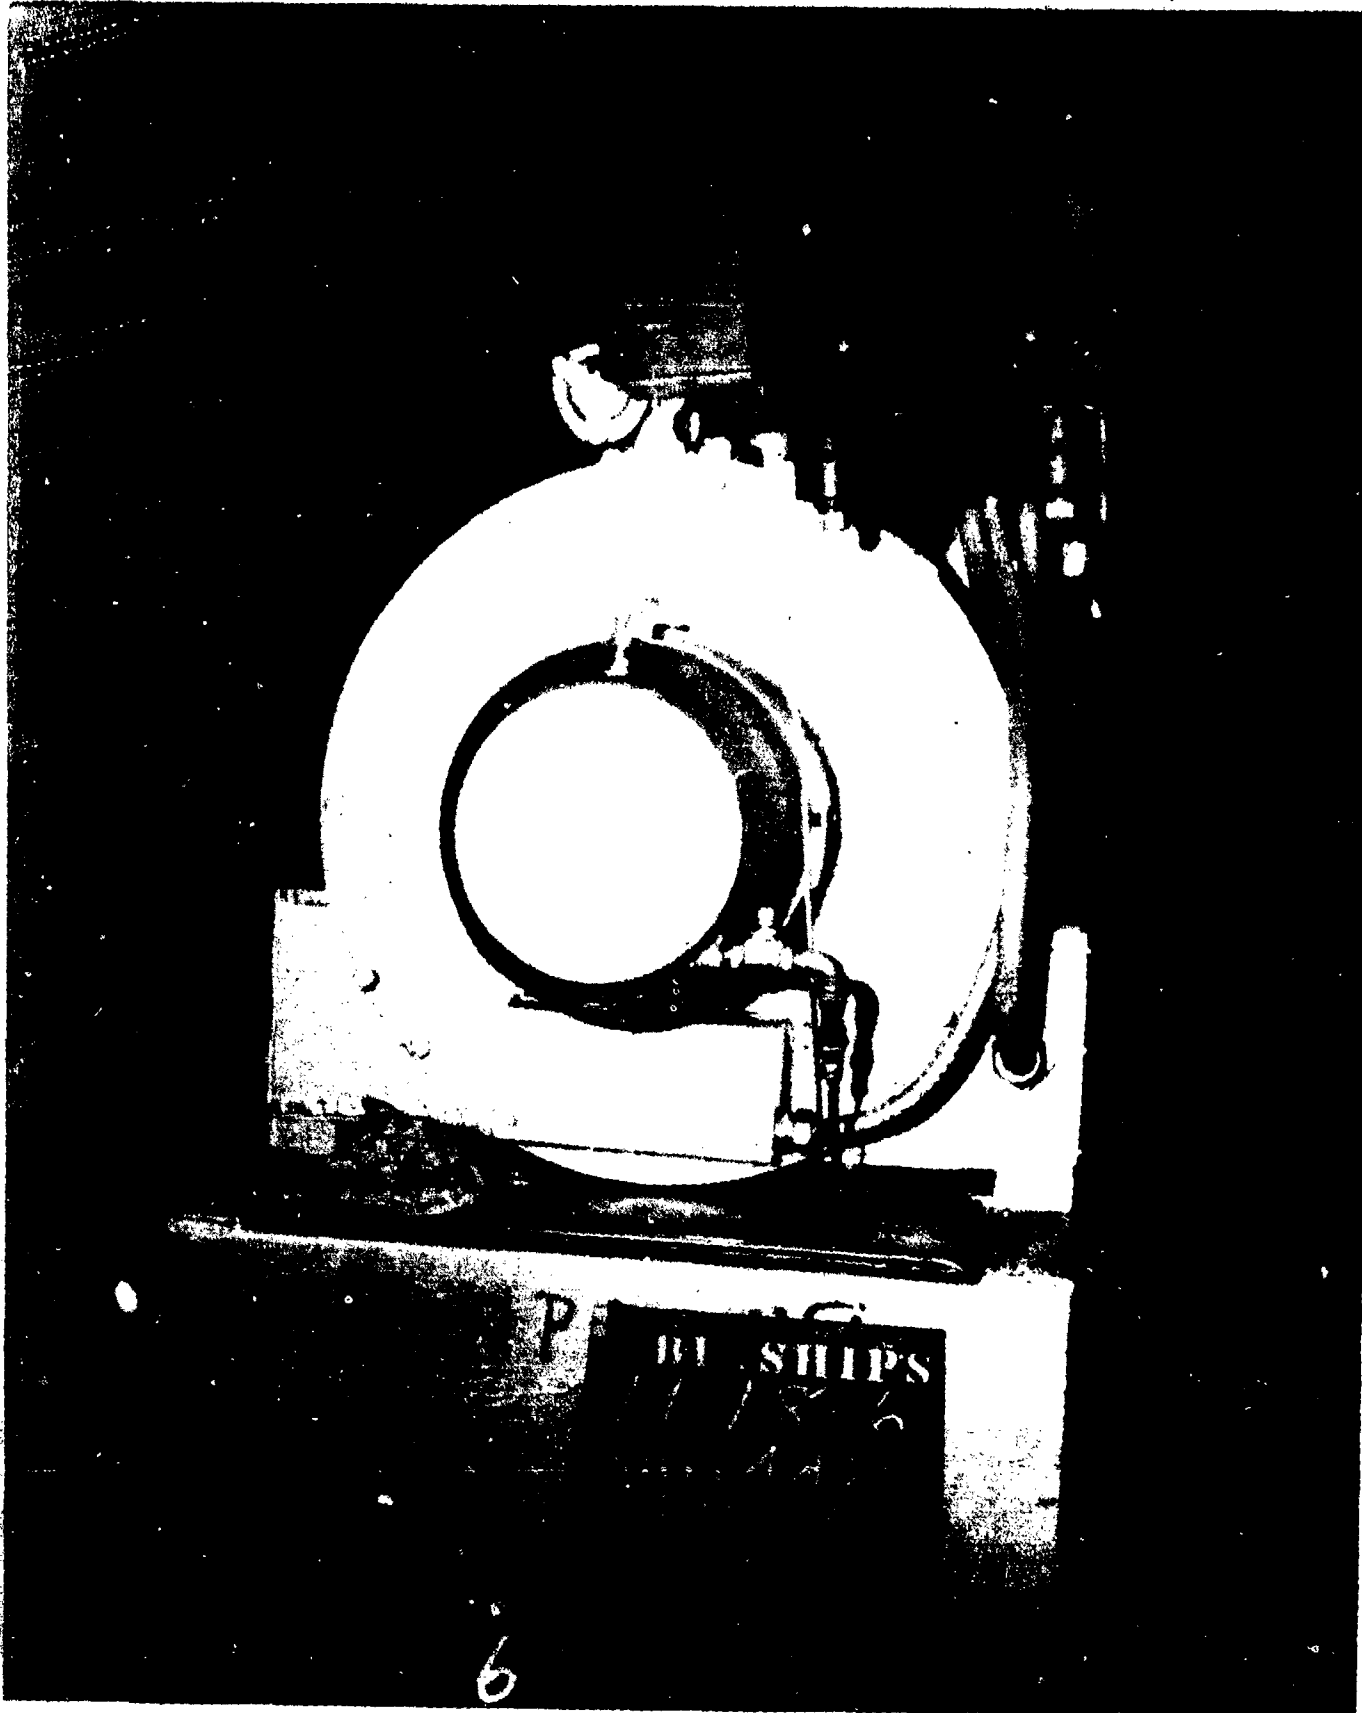
AA-CR-78-1948-6. Showing the damage to the controller for the 60 K.W. diesel generator set. Code 660. 13E1. Forward cargo hold.

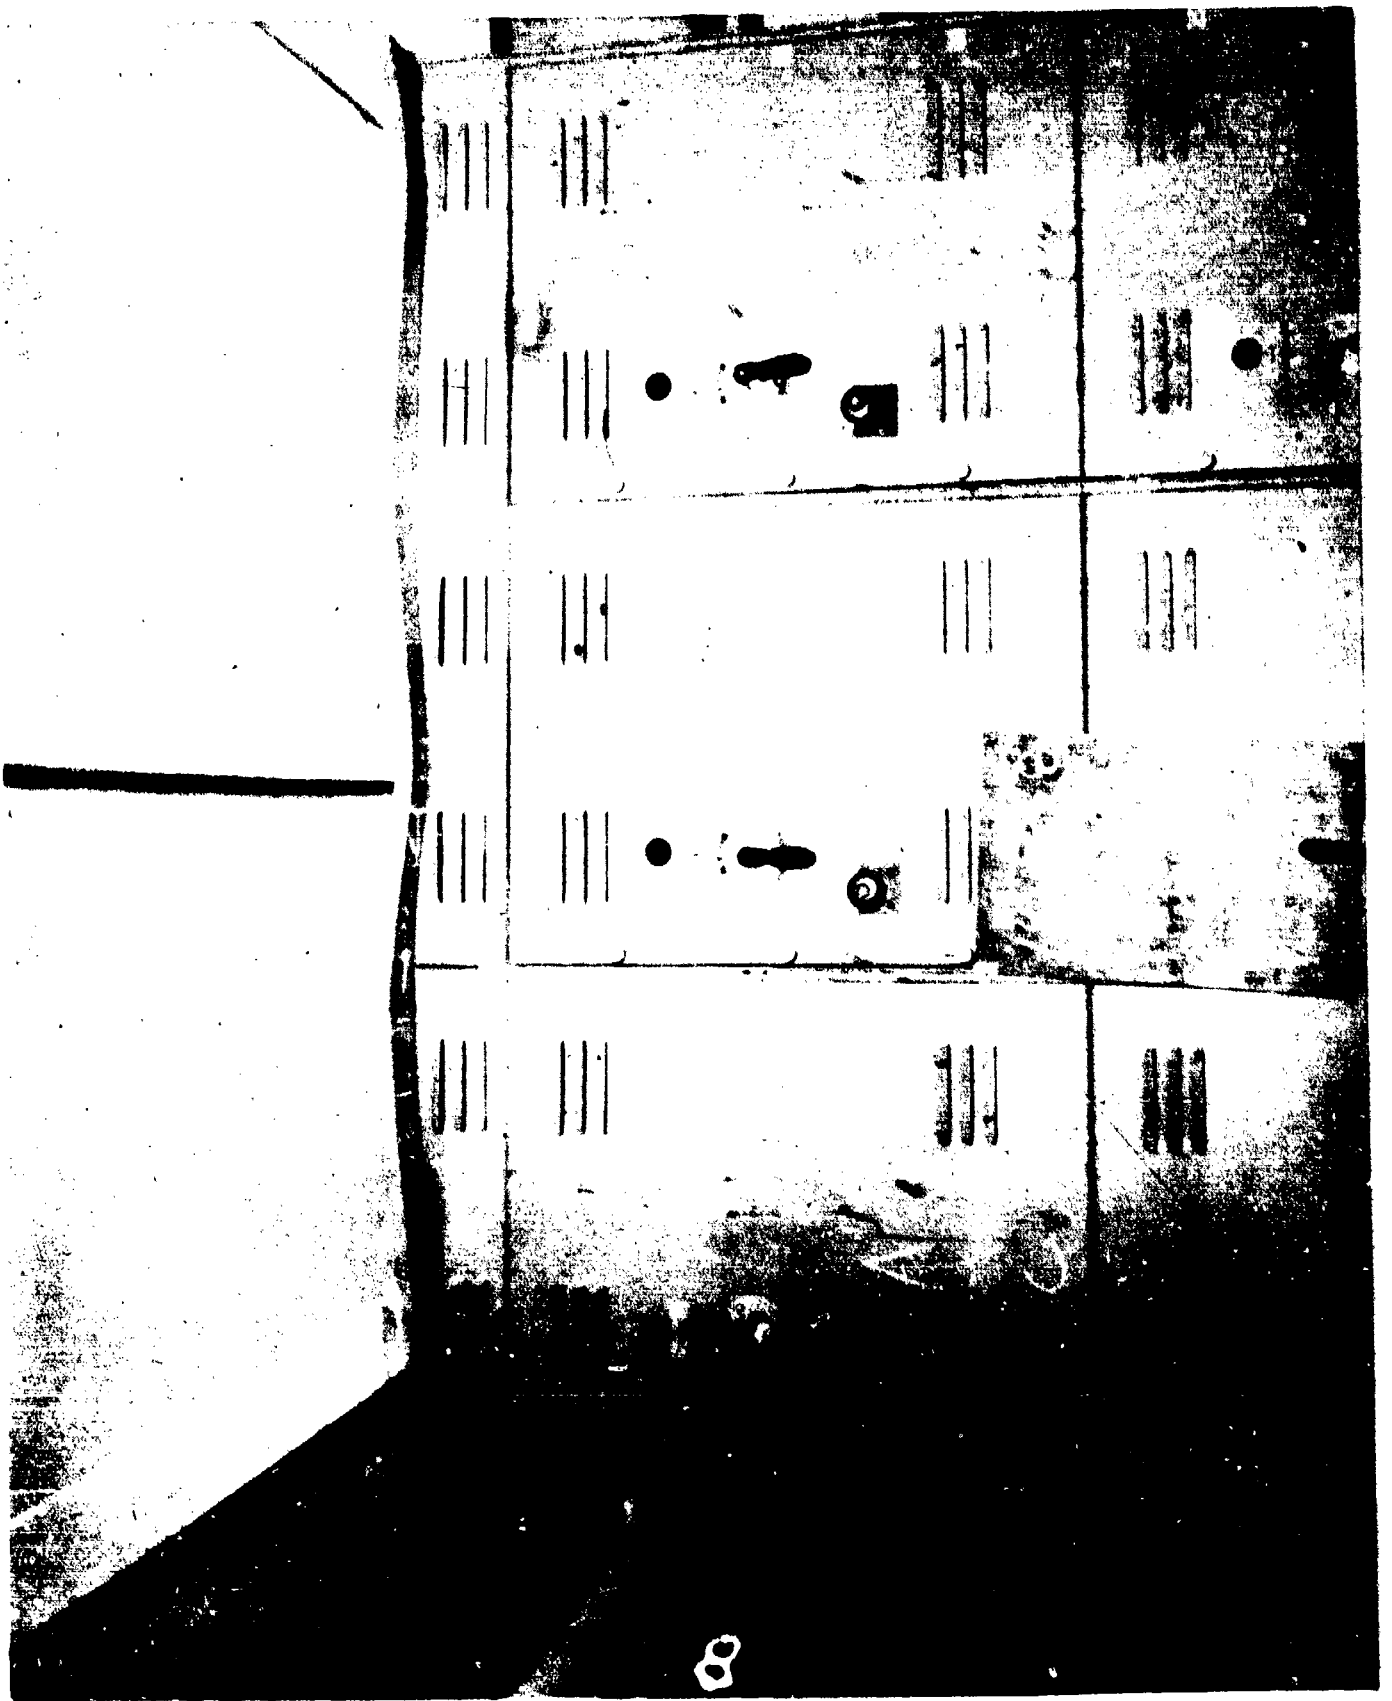
AA-CR-78-1948-8. Showing the damage to the special 660 switchboard, installed for the test, when the overhead came down on it. Code 660, item 13E4. Located in the forward cargo hold.
